# Calcaneus Fracture

- Fractures of the calcaneus (heel) are complex and the treatment is complicated. This calcaneus is broken several times. With the 3D scan the physician is able to locate the position of the single fragments and can check the result of the repositioning.
- This calcaneus was stabilized later by an osteosynthesis (plate and several screws).

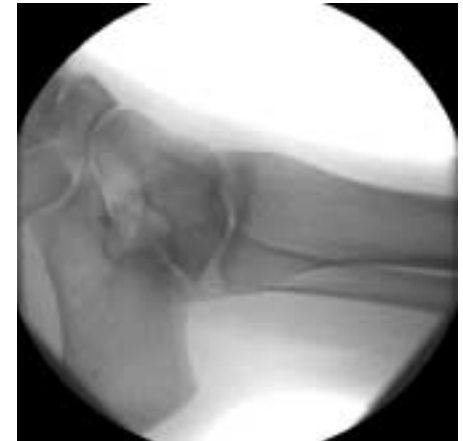
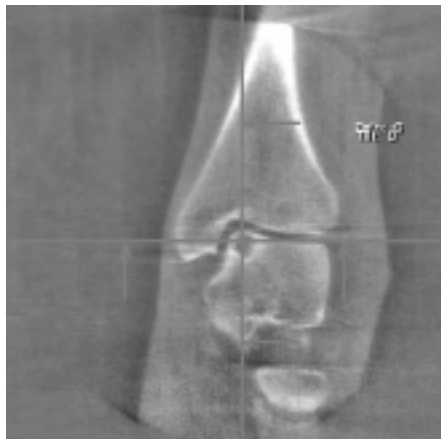
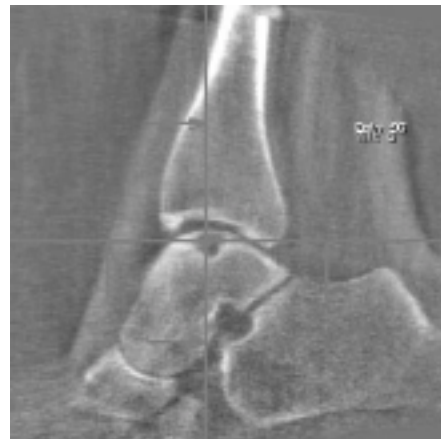
# Talus Cyst

- The talus is part of the tarsal bones and part of the ankle joint. This patient has a cyst in the talus, that means a “hole in the bone”. This cyst is going to be filled with spongiosa through a canula. The 3D scan shows the exact positioning of the cyst which cannot be seen very well in normal fluoroscopy.

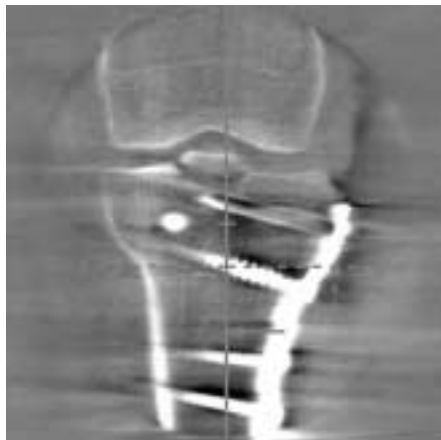
# Tibia Plateau Fracture

- Osteosynthesis (with plate and several screws) of a tibia plateau fracture. There is a serious participation of the knee-joint. 3D shows the correct position of the osteosynthesis and the pieces of the fracture in the joint after the repositioning.

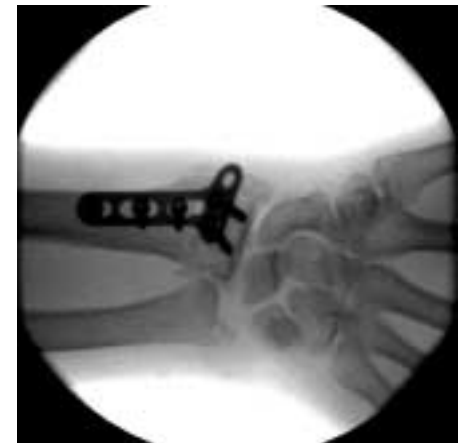
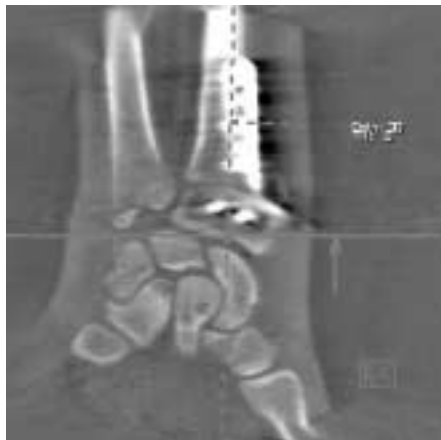
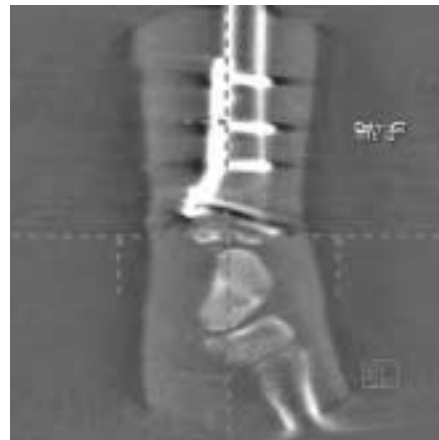
# Radius Fracture

- A broken radius is a very frequent fracture. Here we have a compression fracture with a participation of the joint (wrist) which is fixed by a plate osteosynthesis with five screws. At the end of the operation, especially the surface of the joint is checked. A damage of the joint (e.g. if a fragment remains inside) could lead to an arthrosis of the wrist.
- Note: There is also a small fracture of the ulna.

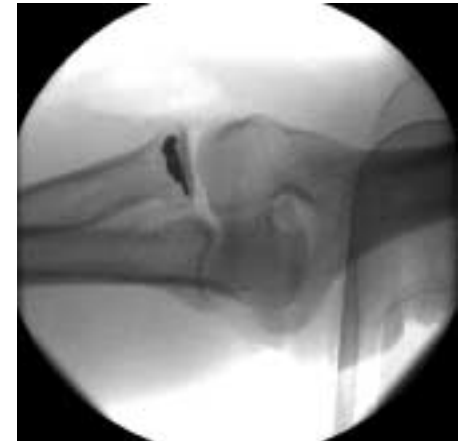
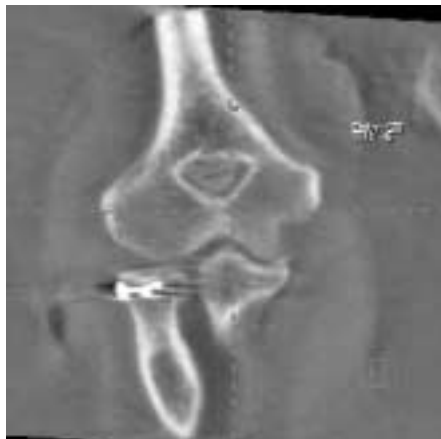
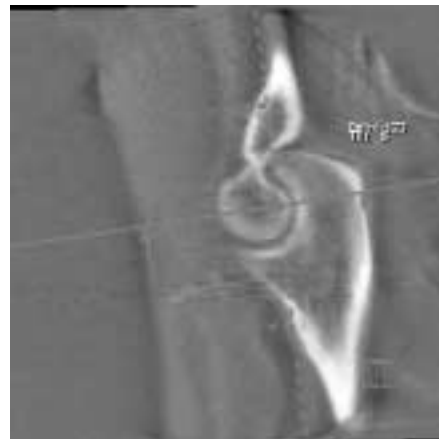
# Elbow Fracture

- The patient experienced a fracture of the radius head. This fracture is very close to the elbow joint and was stabilized by three small screws. With 3D a participation of the joint can be excluded.

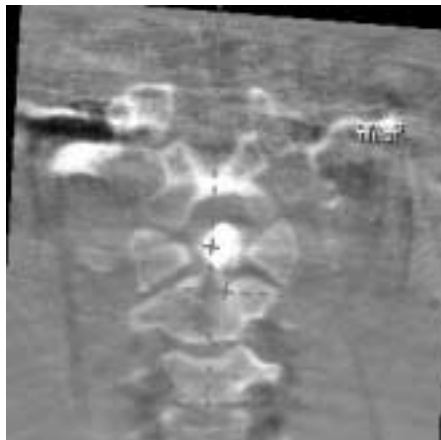
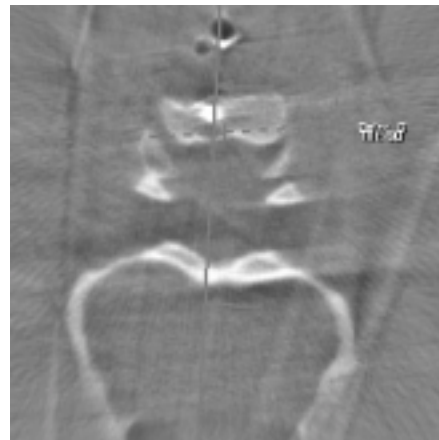
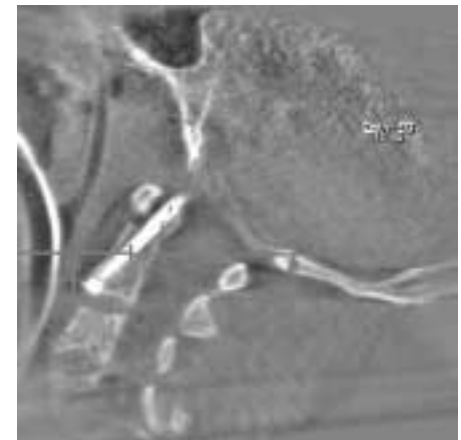
# Dens Fracture

- The dens is a bony structure on the second cervical vertebra. A fracture of the dens is critical because its position is very close to the spinal cord. Because the upper cervical vertebra is overlapped by the head (mandible and/or occiput), the result of repositioning is not seen very clearly in 2D. The result of repositioning can be checked exactly by a 3D scan. In this case 3D shows the position of the screw in the dens.

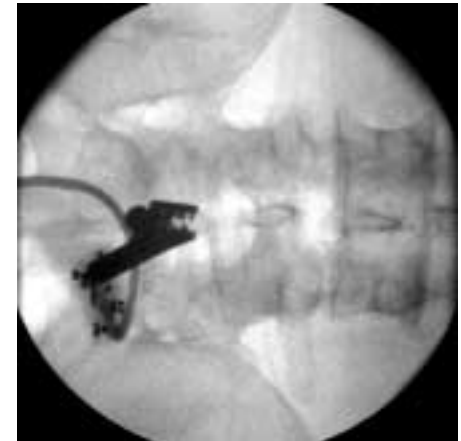
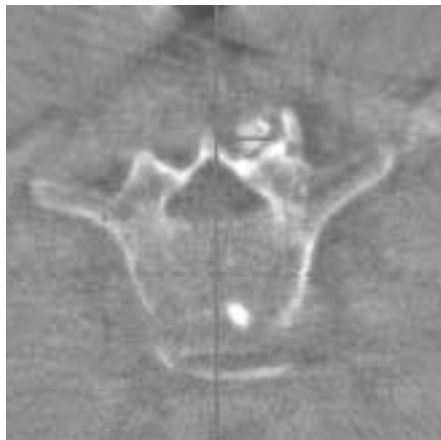
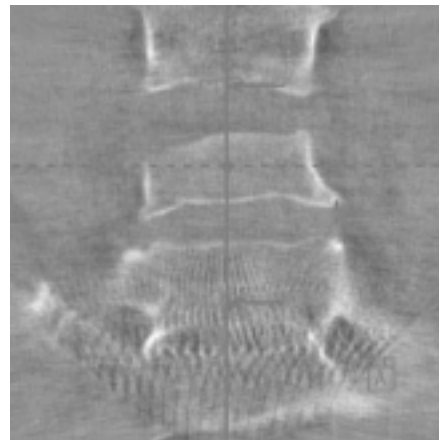
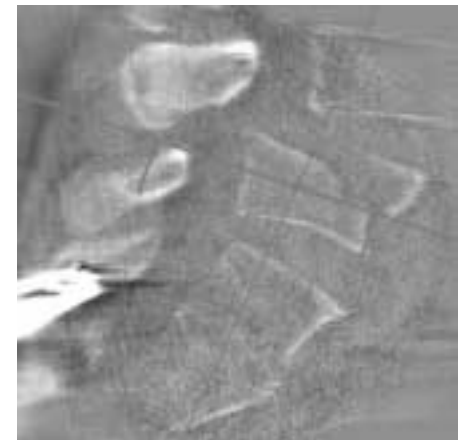
# Lumbar Spine Fracture

- A fracture of the 4th lumbar vertebra is stabilized with pedicle screws (inserted in neighbor vertebrae). On these scan images we see the fracture (still without the pedicle screws) and the metallic “dynamic reference base (DRB)” of the surgical navigation system, which was used in this case.
